THE ORIGINAL FORM OF THE
THEOTOKOS CHURCH OF CONSTANTINE LIPS

Arthur H. S. Megaw.

Theotokos Church of Constantine Lips (Fenari Isa Camii)

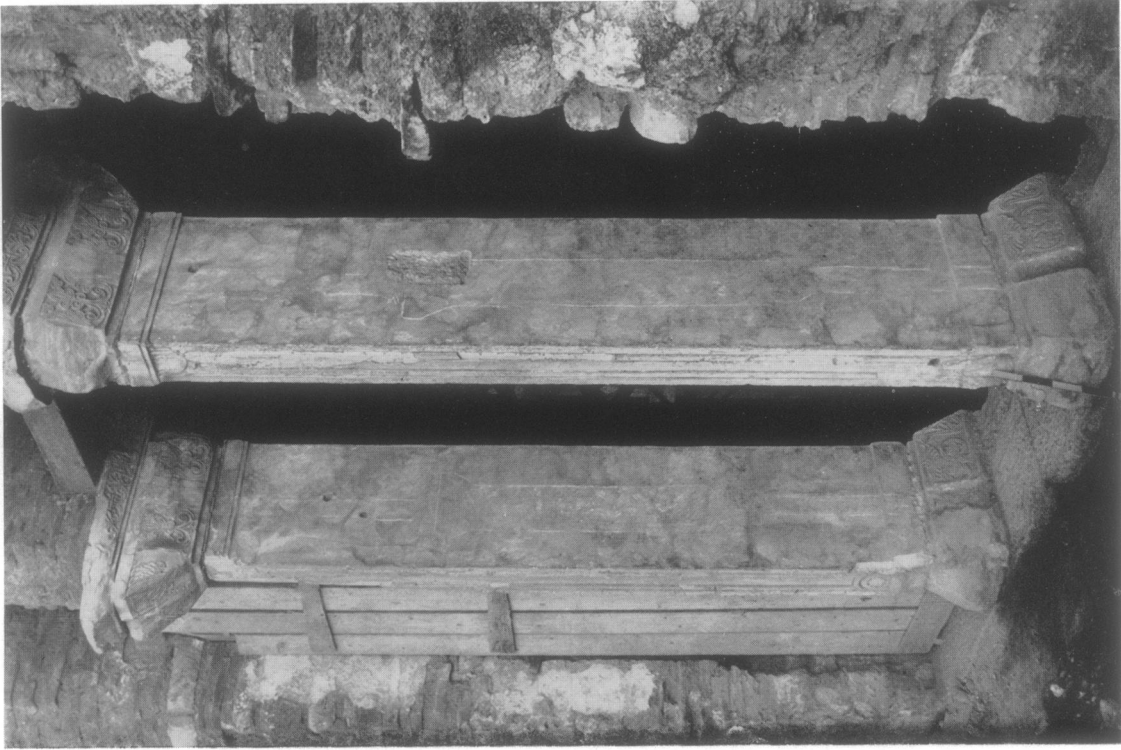
1. Mullions of North Window

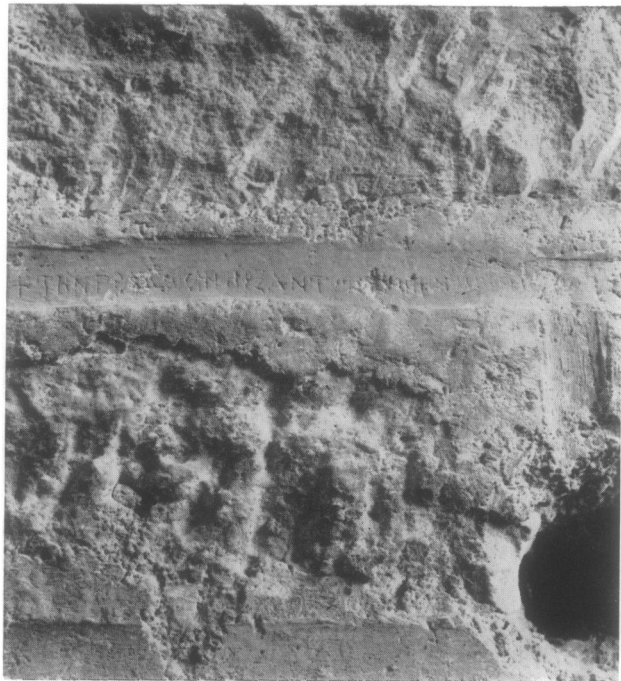
4. Grooved Pointing with Graffito Inscription, detail

⁸ The graffito, visible in this photograph, which was incised when the pointing was still fresh, begins † τὴν γράδωσιν ἤρξαντο...νεῖν μ[ηνί] Νοεμ[βρί]ω κ and presumably records the date on which work on the staircase was begun. Γράδωσις is the word used of the staircase of Carian marble which gave the "Karianos" in the Imperial Palace its name (Theophanes Contin., III, 42, Bonn ed. [1838], p. 139). The graffito, however, is on the north wall of the bema at a height of 1.45 m. above the floor.

Finally, a word about construction will not be out of place. Mention has been made of the characteristic grooved pointing (Megaw fig. 4). This was employed both in the brick-banded masonry which was used for most of the wall construction below the level of the lower cornice, and in the brickwork used for arches and for the entire superstructure. Save in the foundation-walls, this pointing is found throughout the building, both inside and out, notwithstanding the clear intention to conceal it, internally at least, with marble and mosaic. The same care was taken with the initial setting-out and in construction: the angles are true right-angles, the cornices level from end to end, and, making allowance for subsequent distortion, the walls accurately vertical.

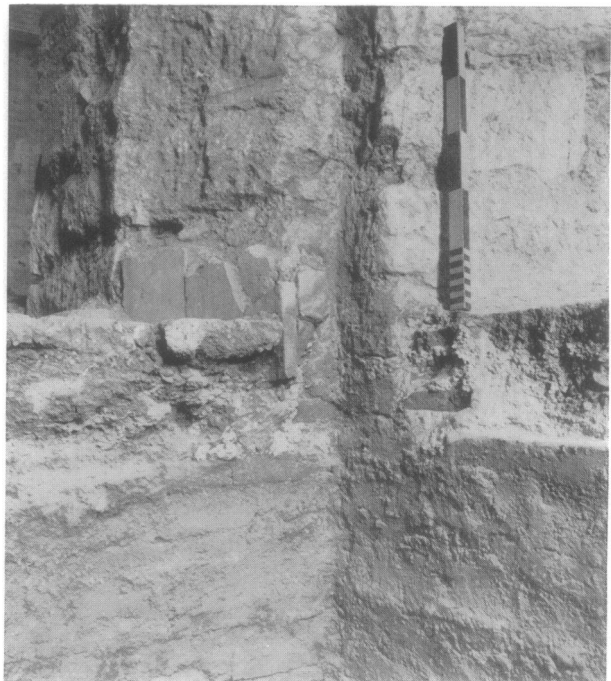
5. Diaconicon,
Northwest Angle, Masonry at Floor Level

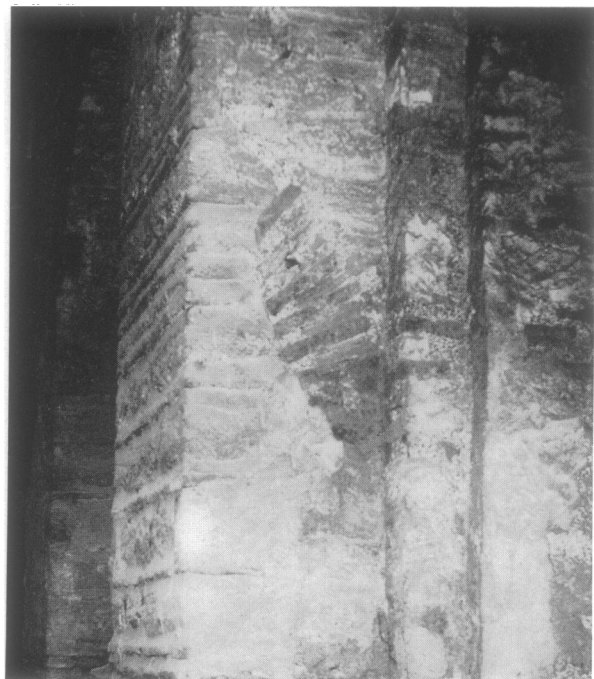
7. South Parecclesion, West Entrance,
North Springing

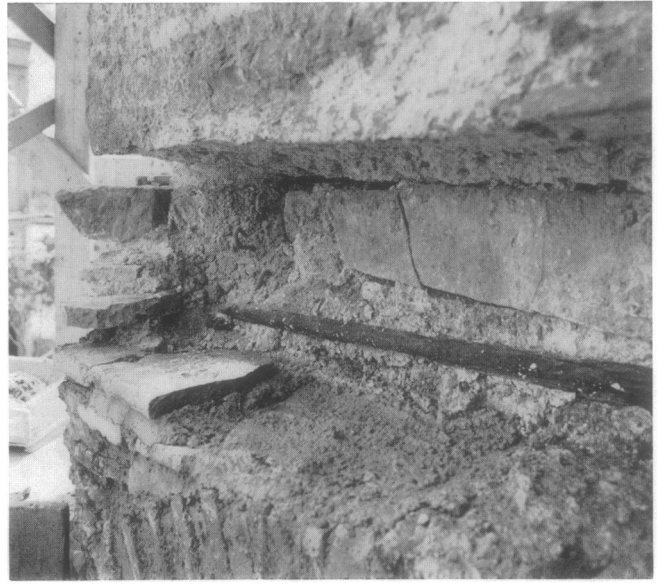
9. Fenari Isa Camii, Main Apse, Wrought Iron Collar below Inscribed Cornice

During the repair of the main apse, remains were found of an upper collar, this time of wrought iron, immediately below the inscribed cornice, which corresponds with the upper internal cornice and with the floor-level of the roof-chapels. Some of the metal had entirely disintegrated, but where it was better preserved it was seen to be formed of lengths of rod about 0.025 m. in diameter (Megaw fig. 9). The couplings were made by forming a head at the end of one rod, somewhat like a nail-head, and passing it through an eye opened in the end of the next rod; the eyes were hammered shut immediately below the heads to form a continuous chain. That it was continuous is suggested by the discovery of a second section at the same level below the sill of the north gable window.

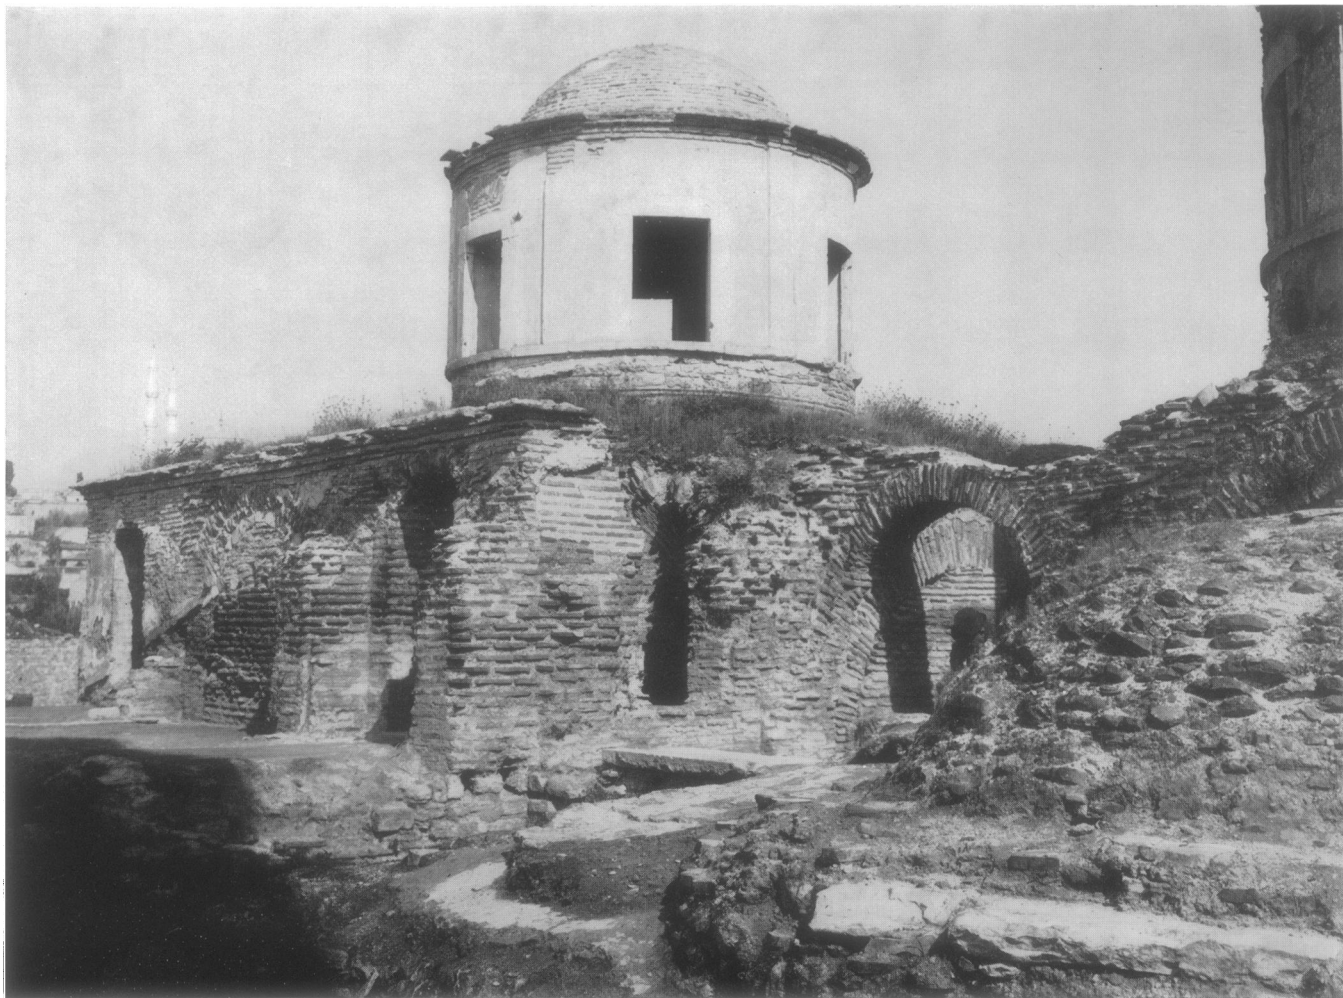
12. Superstructure from Southwest

Mamboury's upper plan (Macridy fig. 9) is erroneous in indicating that the wall that linked the apse of the southeast roof-chapel with that of the south church is of tenth-century date. Macridy accepted this wall (p. 260) as confirmation of Brunov's restoration of a continuous gallery over an outer south aisle, opening into the south arm of the church as well as into the chapels, in the position of the present passage over the north aisle of the south church. But this was a Turkish wall, bonding with neither church, like the arch which spanned the passage at the west end (Megaw fig. 12).²³

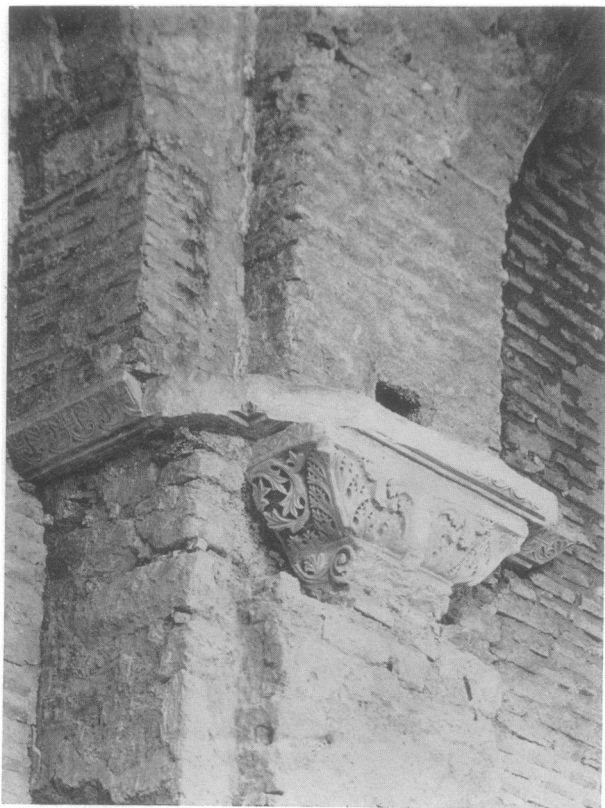
13. South Wall, Half-capital on West Pilaster
